Alatech Home Inspection Service

Report Date
December 1, 2006

Main Street
USA

Report Prepared For:
Mr. Smith

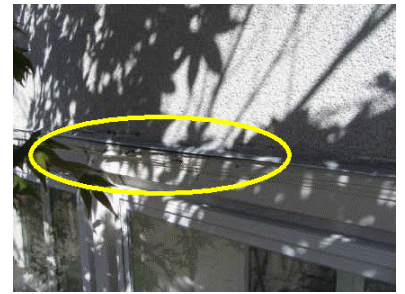
Wood rot.

Major Concern, Repair: The windows show evidence of substantial rot to the window frame. Repair to the window frame can usually be accomplished by a skilled carpenter; a replacement window is preferred in some cases.

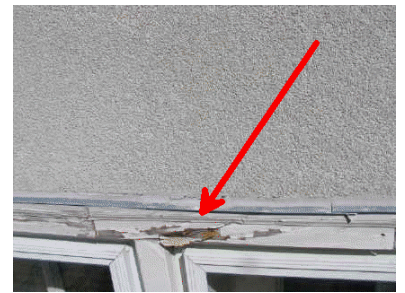
Wood rot above window.

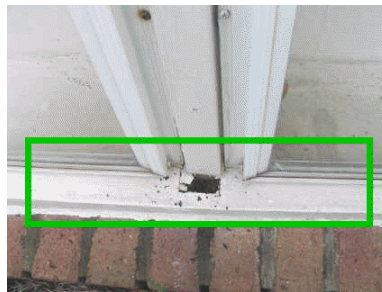
Sill rot behind aluminum

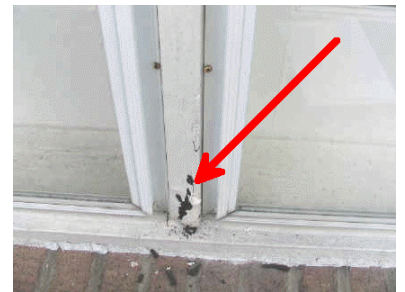
Wood rot.

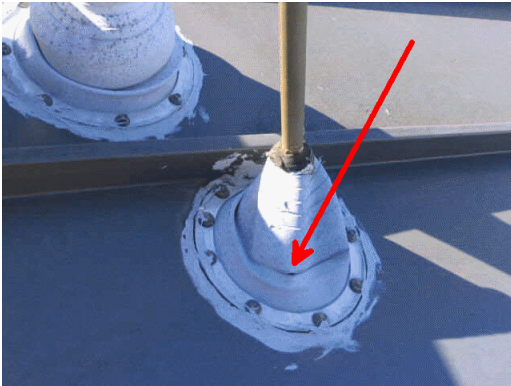
Roof jack flashing is cracking and deteriorated.

Repair: The neoprene flashing around the plumbing vents are deteriorated. SUGGESTION: A competent roofer or sheet metal technician should repair or replace all missing, improperly installed, damaged or deteriorated flashings, to restore an effective seal at all points.

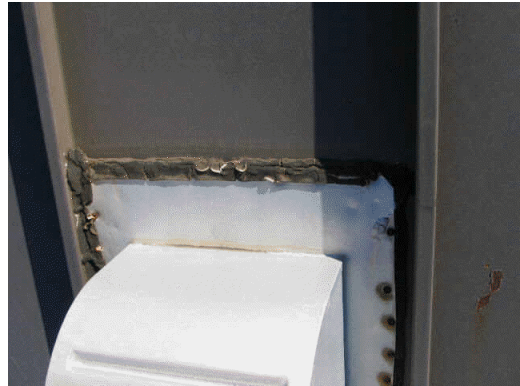
Sealant deteriorated around roof vent.

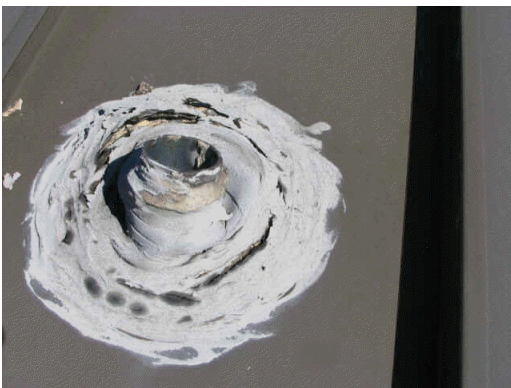
Roof flashing deteriorated on the left side.

SUGGESTION: All missing, improperly installed, damaged or deteriorated flashings should be replaced by a competent roofer or stucco technician to restore an effective seal at all points.

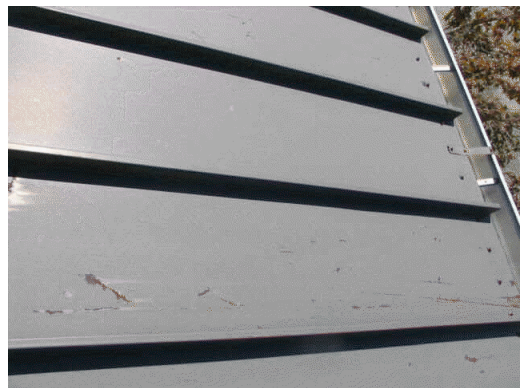
Roof rusting.

Repair: The metal roof is rusting. The roof needs to be sanded, primed and painted.

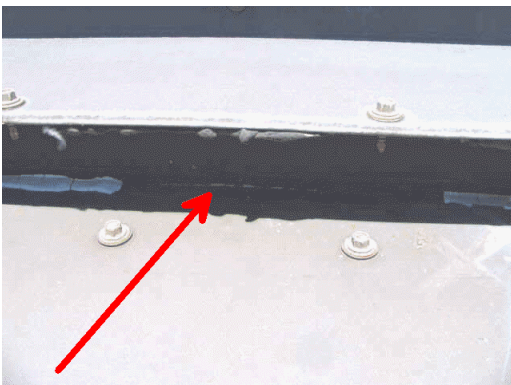
Caulk deteriorated along the joint on the upper roof.

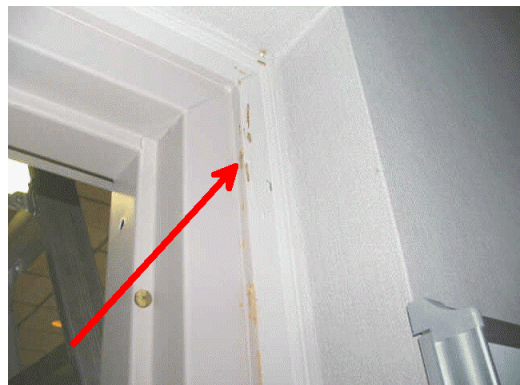
Insects have damaged the door jamb to the store room.

Repair: Evidence of insect damage was observed and there is risk of additional hidden damage. If the property has not already been treated, a licensed pest control specialist should be obtained to evaluate the structure for any ongoing activity within the building. Damaged wood should be repaired or replaced.
